**LADSAF EQUIPMENT
REPLACEMENT REPORT**

Job Location	Sample Site Site# 000-0001	Technician Name	Entropy Tech Services p 0400 122 157 www.entropy.info
Completion Date	April 2016	Technician Sign Off	XXXXXX

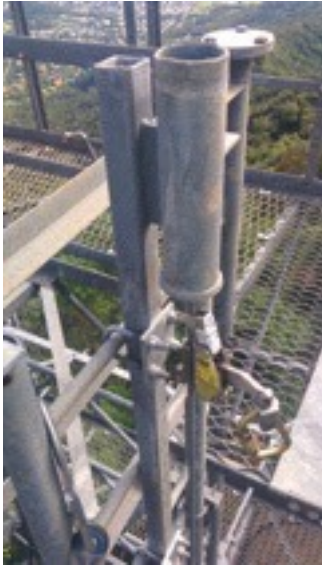
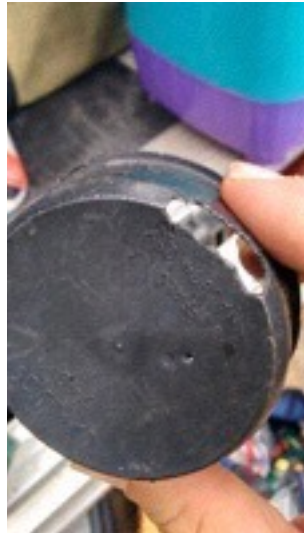
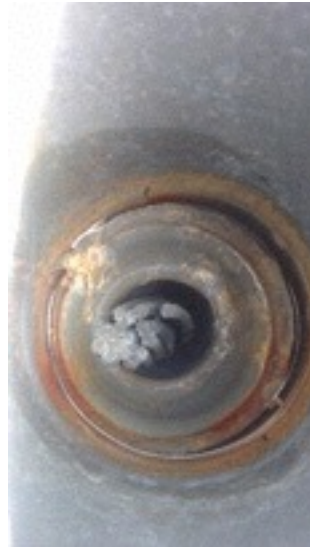
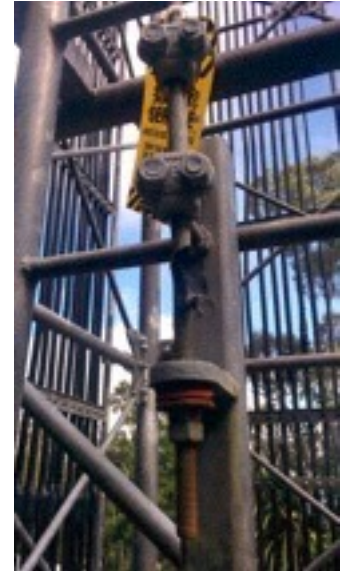
Before Images:

Part Replaced	Replaced Yes/No	Issues to note	Part Number
Top Bracket and Cap:	Yes	T.B. replaced due to internals corroded due to water ingress thru hole in top cap.	LS-B kit Gal Steel T.B.& Cap.
Bottom Bracket and Tension Ring:	Yes	B.B replaced due to corrosion on tension washers, nut and bracket. *Previous bottom bracket installed upside down on ladder.	LS-B kit Gal Steel B.B. & Ring.
Cable:	Yes	Original cable in serviceable condition therefore re-used.	LS001-1/19-G LADSAF Cable Gal.Steel 10mm Dia.
Cable Guides:	Yes	2x cable guides installed as none previously installed.	#6100540
Inspection Plate Stamped:	Yes	Inspection plate stamped in and new parts inspected and passed for service. All Clear	N/A

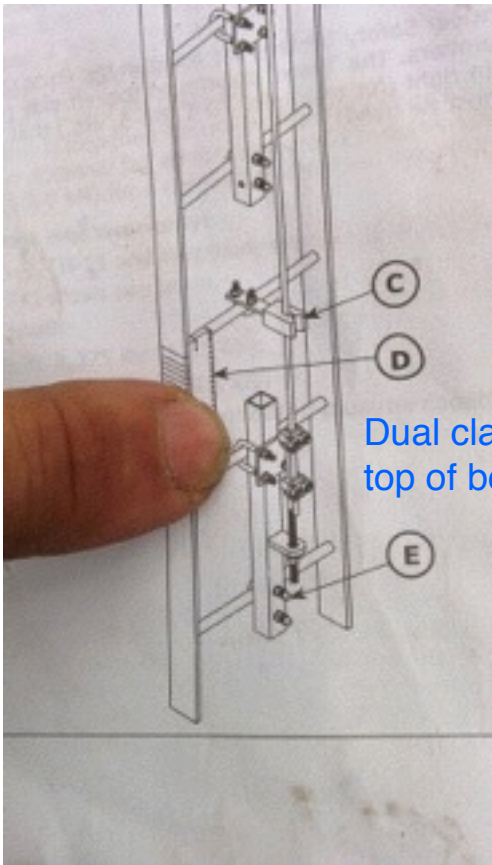
Dual clamp should be at top of bottom bracket.

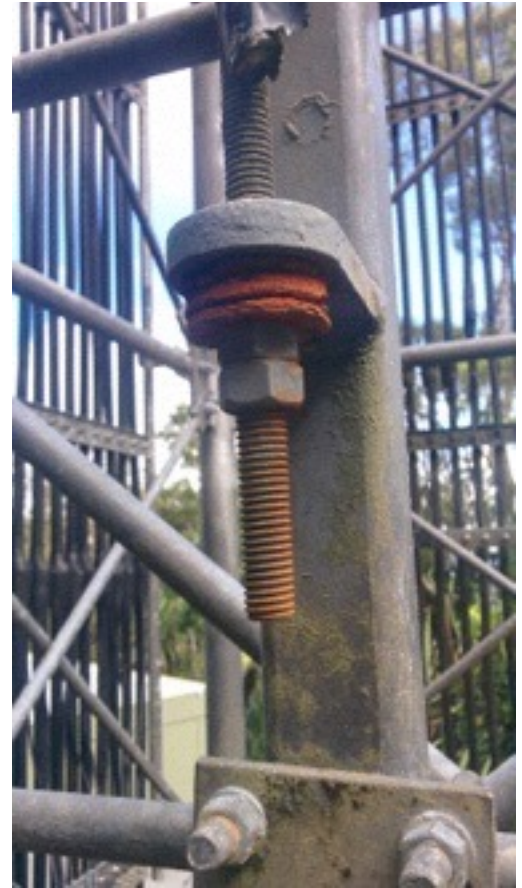
Previous install was at bottom (inverted).
